Sudden Building Collapse

An Evaluation of a New Risk in Operational Fire-fighting

An Independent Analysis

Written by P S Kayley BA (Hons)

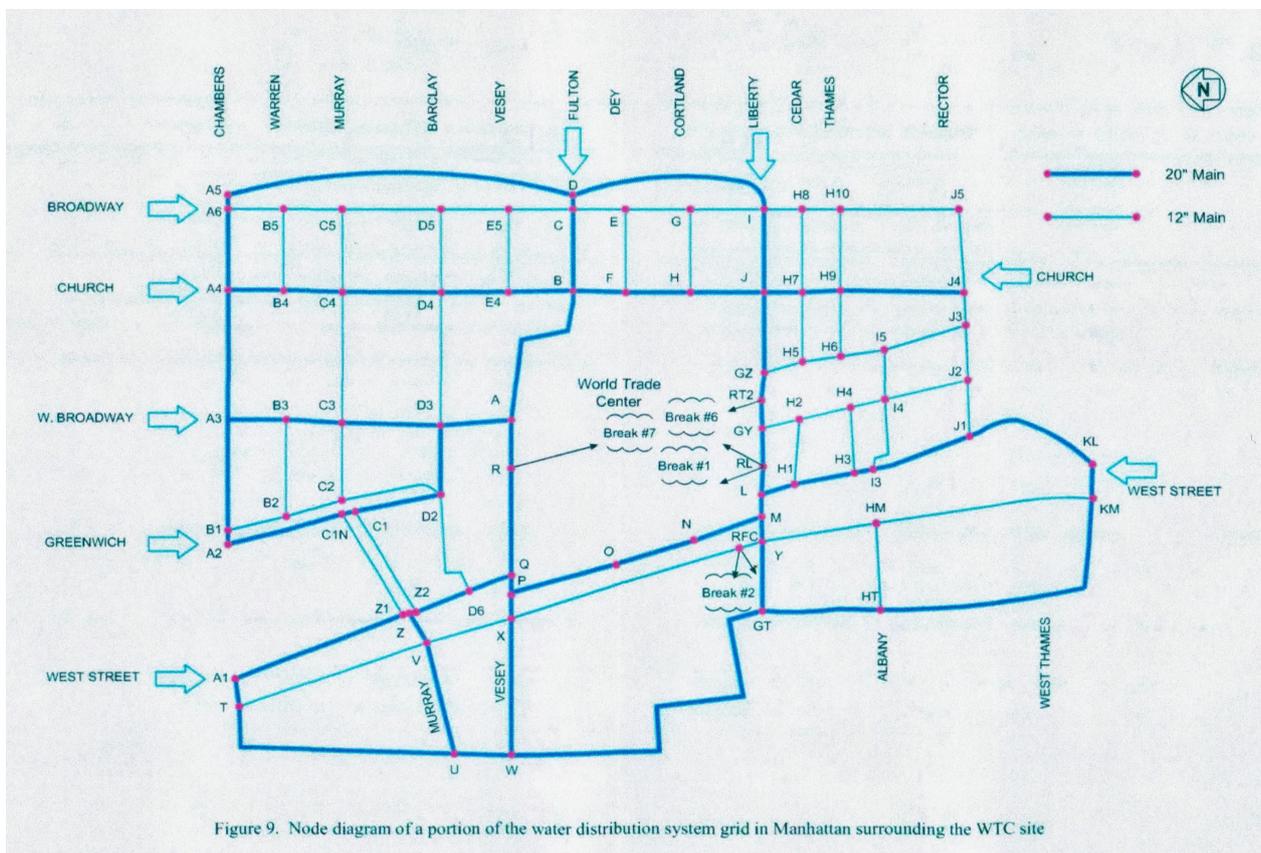
Figure 9. Node diagram of a portion of the water distribution system grid in Manhattan surrounding the WTC site

The combination of 20-inch primary and 12-inch secondary mains connected to a gravity fed supply with enormous volume capacity represents a very robust water distribution system.

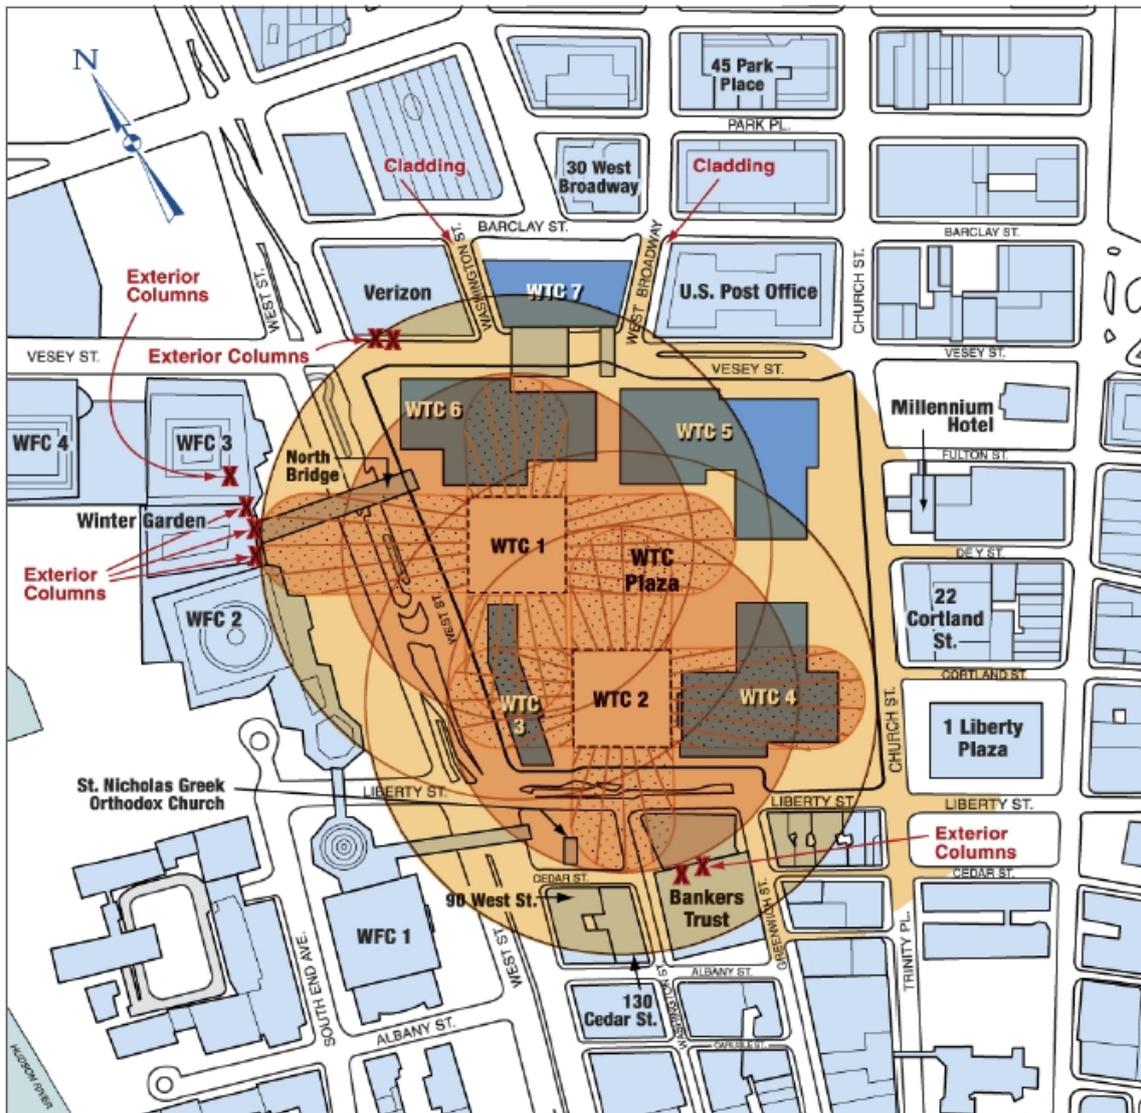
The breaks that were identified to the city water mains, were found during the clean-up and repair operations. A number of these breaks did not occur during the incident and would not have affected WTC7. **It is reported that the breaks which occurred to the north of the twin towers have been attributed to either the collapse of Building 7 or to the movement of heavy equipment after the incident, and therefore would not have had a detrimental effect on WTC7's water supply and fire-fighting operations.** (Ref) Debris around WTC7, including surrounding streets, was documented as being "light" in the 2002 FEMA report (see figure 1-7).

Figure 1-7 Schematic depiction of areas of collapse debris impact, based on aerial photographs and documented damage. Striped areas indicate predominant locations of exterior steel columns. Inner circles indicate approximate radius of exterior steel columns and other heavy debris. Outer circles indicate approximate radius of aluminum cladding and other lighter debris. Heavy Xs show where exterior steel columns were found outside the predominate debris areas.

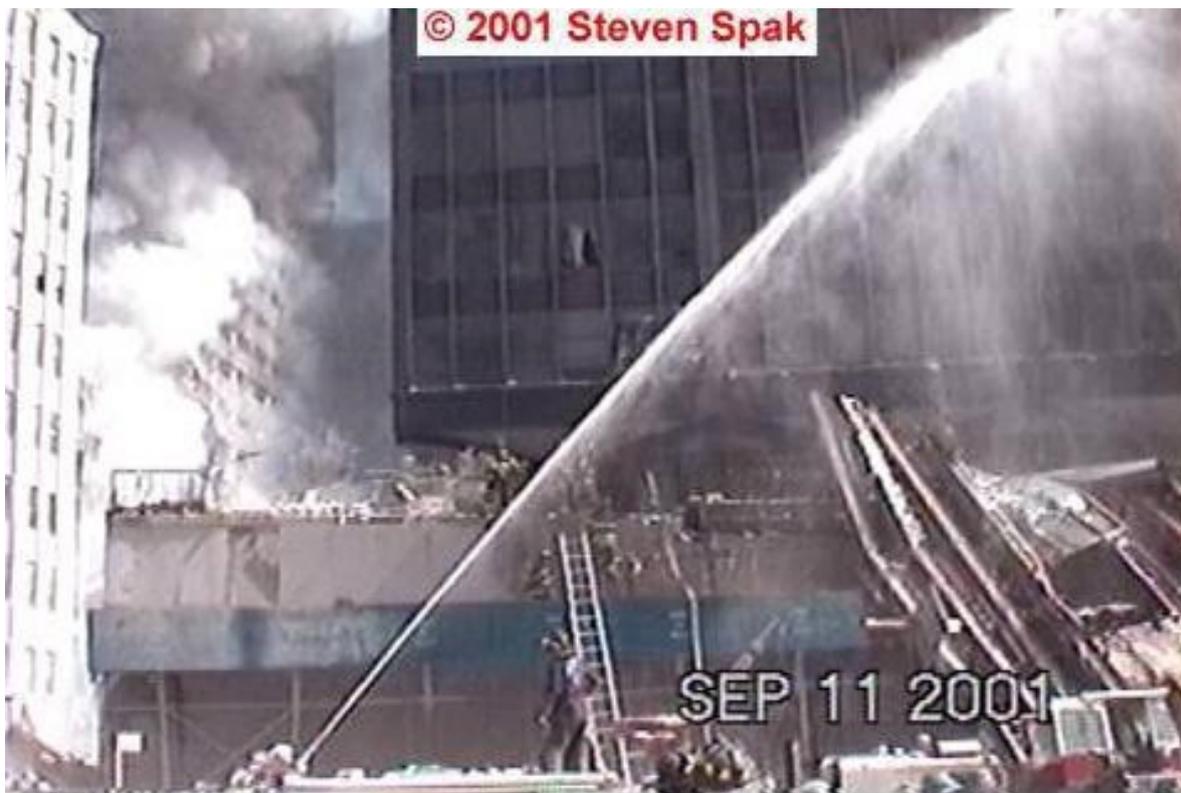
The following is photographic evidence of water availability. This is an image at 1:30pm with the south face of WTC7 in the background.

Figure 5–48. Frame taken from a video recorded shortly after 1:30 p.m., showing a partial view of the south face of WTC 7.

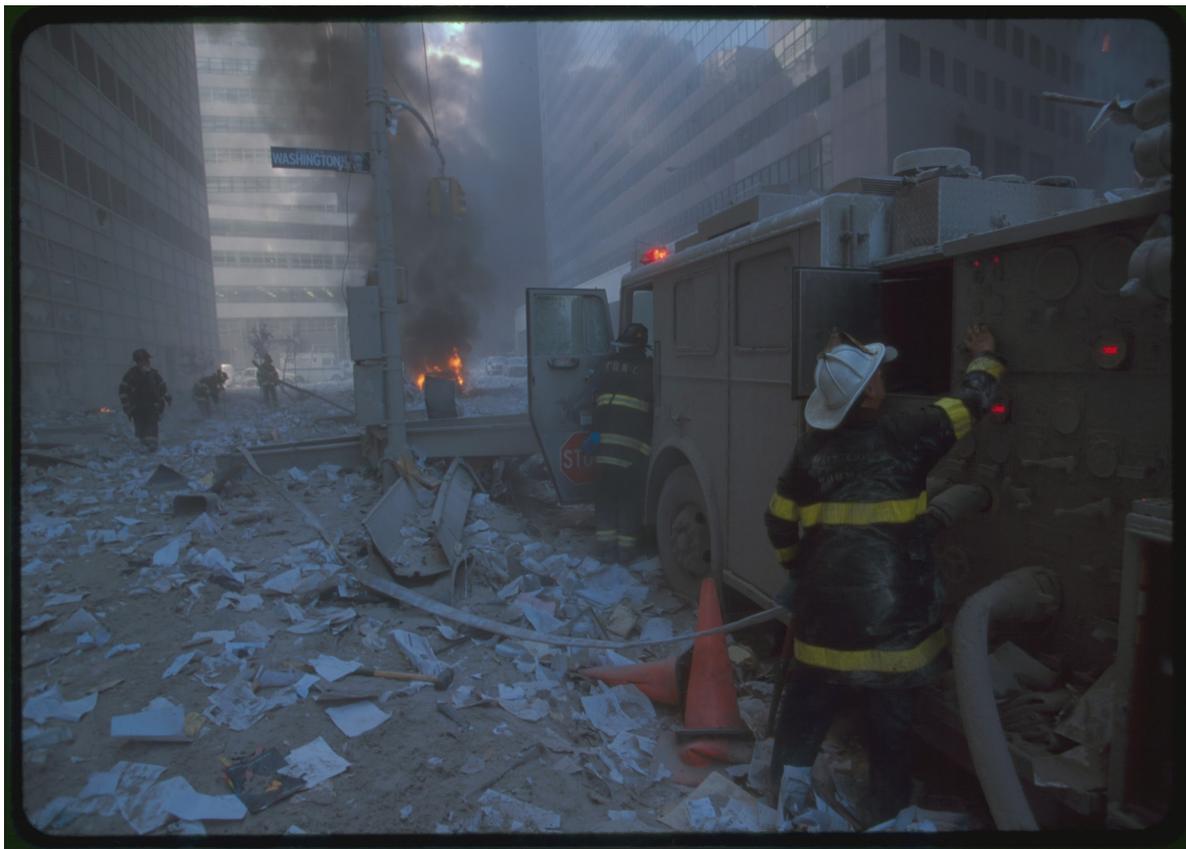
In the following picture, WTC7 can be seen in the background to the right. The fire appliance is parked at the corner of Barclay and Washington Street; the time is shortly after 10:30am. It appears to have a fat hose delivering water to the pump. The Firefighters are operating the appliance and maneuvering a hose in the background in the vicinity of a small fire. This too suggests a healthy water supply.

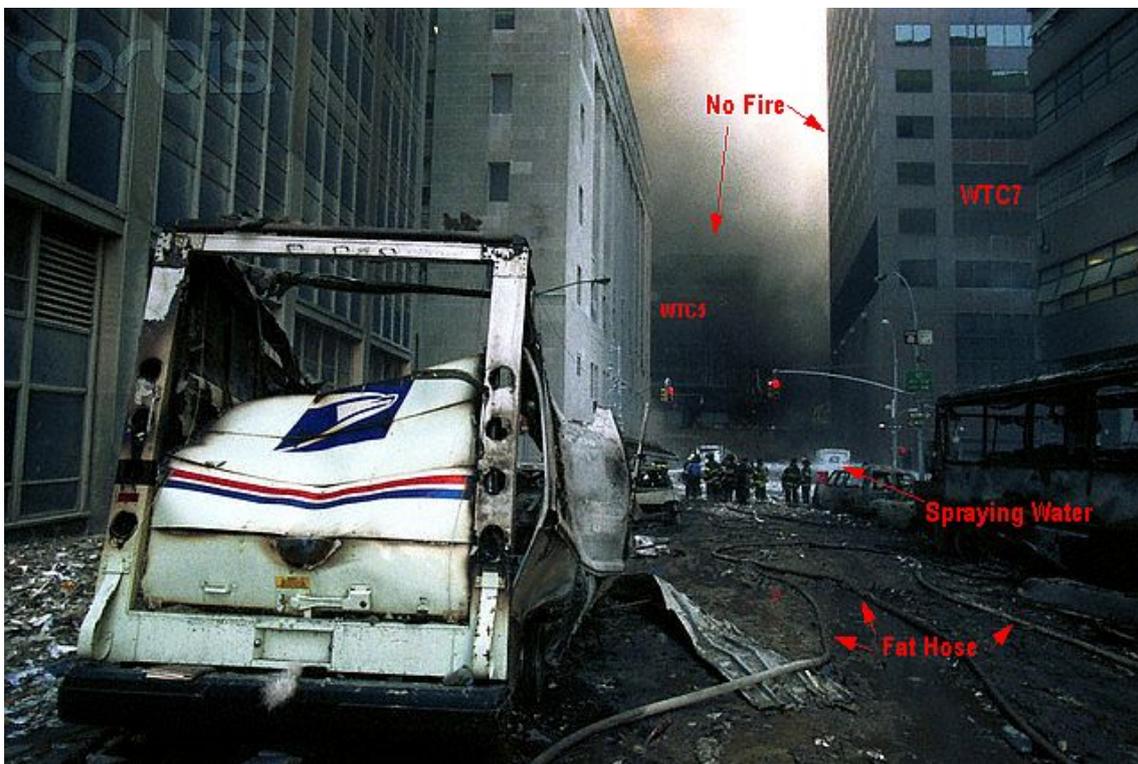
In the next shot, firefighting operations can be seen outside Building 7 soon after the collapses of the towers.

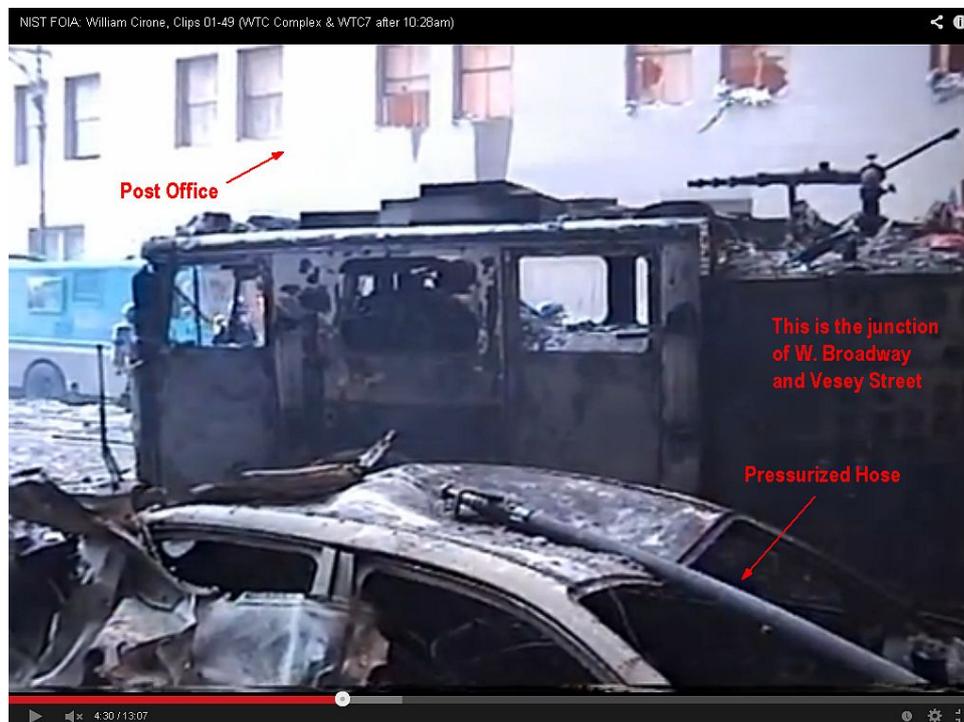
The picture below shows an appliance parked in front of the east entrance to WTC7. A pressurised hose resting on top of the car. However, this does not necessarily mean a good water supply. The delivery branch is closed, but so too could the delivery outlet be closed, thus trapping water at pressure in the hose and giving the appearance of a good water supply. But based upon all the other evidence of ample water pressure it's probably also worth recognition.

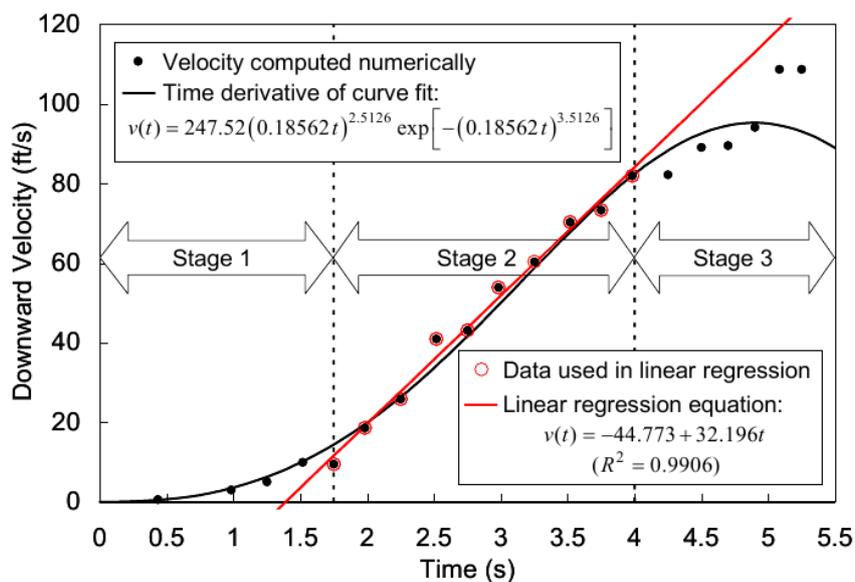
Figure 3–15. Downward velocity of north face roofline as WTC 7 began to collapse.

The graph shown above was added at the last minute into the NIST final report. The red line through the data has a slope of 32.196 ft/sec² (i.e. 9.81 m/s²). Thus NIST's own measurements in its final report concur that freefall occurred. They simply avoid reporting to the public the true implications of what this result identifies.

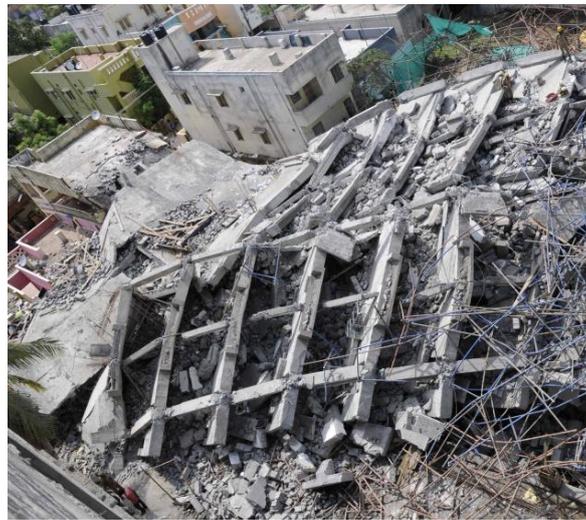
Normal gravitational building collapse retaining large sections of concrete

Normally, when a building collapses without explosives, a lot of the building, like floors and other reinforced concrete sections, remains intact creating voids where casualties can survive. Specialist Fire and Rescue teams are known as USAR and are trained to locate and extricate casualties in these situations. As previously mentioned, this was not the case with WTC7.

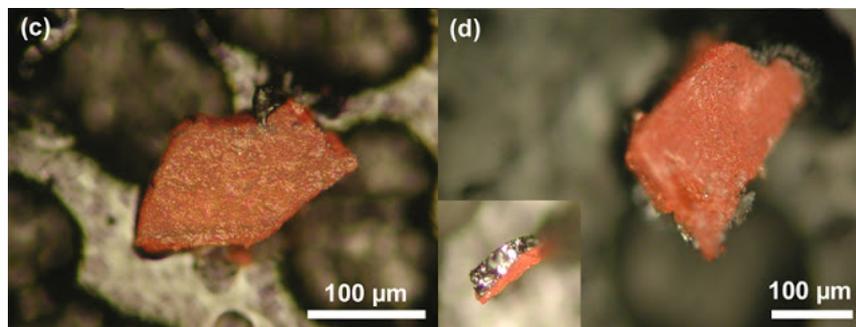
Photomicrographs of active thermitic material found in samples of the WTC dust

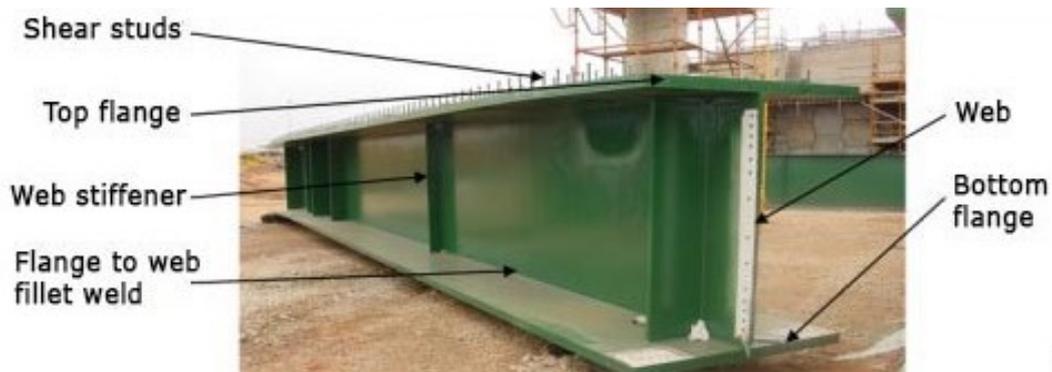
Shear studs

Shear studs, as seen in the two diagrams, are short unthreaded bolts welded to the top flange of a steel girder. The shear studs become embedded in the above concrete flooring slab to form a composite beam, which then acts structurally as one beam which is stronger than the steel beam.

In the 2008 NIST Final Report, it was said that the key girders did not have shear studs. The fact that these girders did not have shear studs was then said to play a crucial role in the chain of events leading to the building's structural failure:
