# Areas of Specific Concern in the NIST WTC Reports

*Below is a series of twenty-five provable points which clearly demonstrate that the reports produced by the National Institute of Standards and Technology (NIST) on the destruction of the World Trade Center (WTC) were unscientific and fraudulent. Therefore NIST itself – including its lead authors, Shyam Sunder and John Gross - should be investigated.*

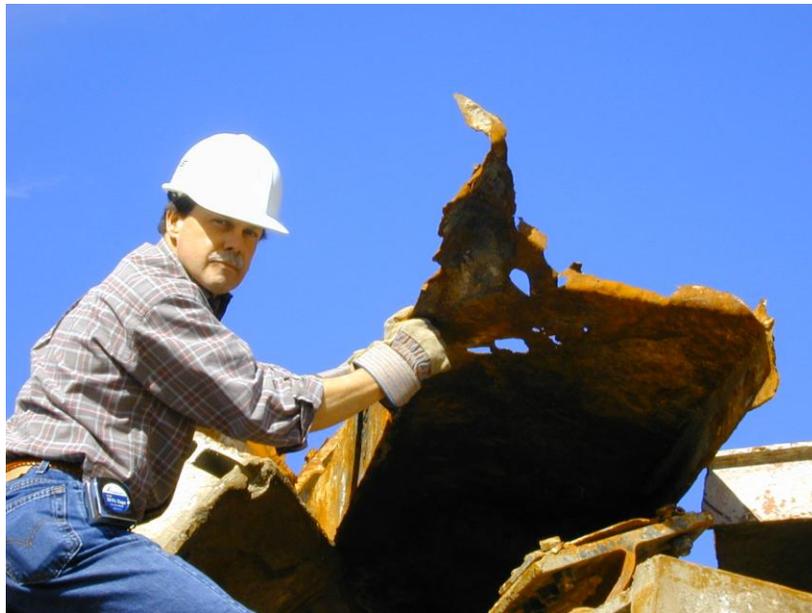
In February 2012 an FOIA request produced three photos, taken during October 2001, showing Dr. John Gross of NIST posing with a heavily eroded WTC 7 beam. These photos contradict Dr. Gross' statements about not witnessing steel that had been subjected to high temperatures. In fact, Dr. Gross was on the team headed by Dr. Jonathan Barnett, who was responsible for discovering, during the FEMA investigation, the WTC 7 beam featured in the Appendix C forensic analysis, which was melted and sulfidated. This is one of the steel beams the ends of which Barnett had previously described as "partially evaporated." Such evaporation required temperatures exceeding 4,000° F.
