Sudden Building Collapse

An Evaluation of a New Risk in Operational Fire-fighting

An Independent Analysis

Written by P S Kayley BA (Hons)

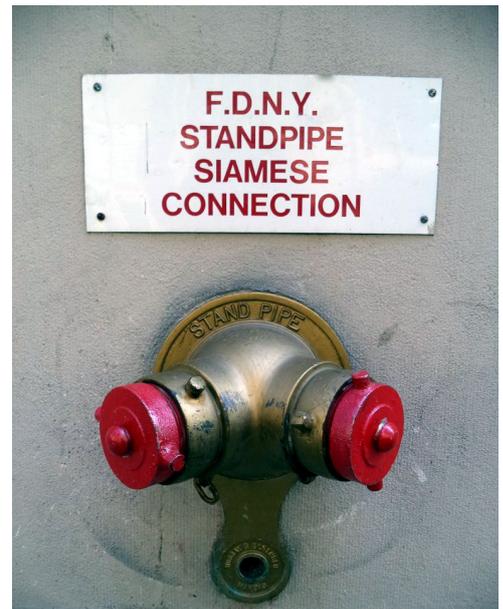
The WTC7 sprinkler system was connected to two separate building main lines and two separate city water mains. *“Water for the fire standpipe [riser] and sprinkler system is supplied through two separate 8-inch building main lines connected to two separate city mains.”* (Ref). NIST states that the water main supply to the sprinklers was severed, which means both of its supply mains would need to have been broken.

If the mains water pressure being supplied to the building had been too low the system should still have coped. The system was designed to operate with varying city water main pressure situations - “During a fire emergency, automatic fire pump FP-1 will increase the pressure of the city water to provide system operating pressure. Jockey pump JP-1 will maintain required system pressure at all times.” Should these automatic pumps have failed there was a backup pump which could have been operated manually to maintain system water pressure. (Ref)

In the unlikely event that water was limited to the building from both separate mains water supplies being broken, or simply in order to boost the system, the sprinkler system also had the capacity to be charged with water from external Fire Department connections to the building (siamese fittings). These were located on outside walls at Washington St., West Broadway, and the loading dock.

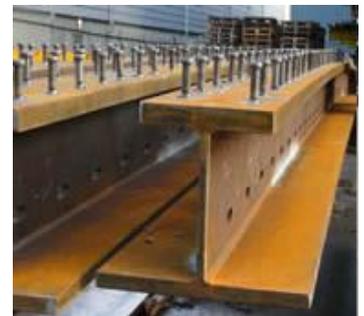
*Floor beams and exterior spandrel beams had shear studs, but the girders that supported the floor beams **did not** have shear studs -(NIST NCSTAR 1-9: 462). In WTC7, no studs were installed on the girders. -(Ibid.)*

NIST explained that if the shear studs had been included, connecting the girder directly to the floor as a “composite girder” structure, the structural failure would not have occurred due to an increased lateral stiffness of the girders preventing the floor beams from expanding freely. (Ibid., 347-48)

NIST used the theoretical absence of these shear studs as a reason to explain WTC7's collapse, compared with other buildings which stayed upright in the face of more aggressive fires. They explained that those buildings' structural design and construction was different, citing the use of girder shear studs in those buildings as a reason for their greater resilience to stress from fires (NIST, NCSTAR, Draft 2008, 341 and 525). This was used repeatedly by NIST to explain this difference and was indeed a strong argument identifying a causal relationship. The following sentence is repeated twice in the draft report, “Additional factors that contributed to the girder failures were the absence of shear studs that would have provided lateral restraint.” (Ibid., 535 and 603)
